Vol. ChE 32, No. 1, April 2024

### Technical Investigation on Baily Road Green Cozy Cotez Restaurant Fire: Incident Analysis and Lessons Learned

Easir A Khan

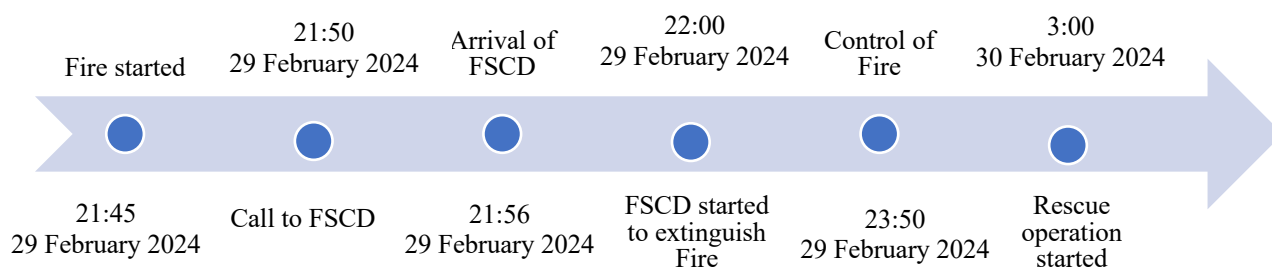
Figure 01: Incident timeline of Green Cozy Cotez Restaurant Fire (Thursday at 21:45, 29 February 2024)

On 29 February 2024, fire initially started at the ground floor at around 9:45 pm local time (BST) and quickly spread all over the building. The incident timeline is shown in Figure 01. Fire service personnel reached to the scene quickly and started to extinguish fire. However, fire spread very quickly to the whole building before the fire service personnel came. Fire initiated at the chumuk coffee shop located close to the main entrance as shown in Figure 02 building layout. The building has two lifts and one staircase which completely blocked by smoke and heat immediately after fire started. The people at upper floor were trapped in the fire and unable to evacuate and consequently 46 of them died because of direct burn injury, oxygen deficiency and/or smoke inhalation.

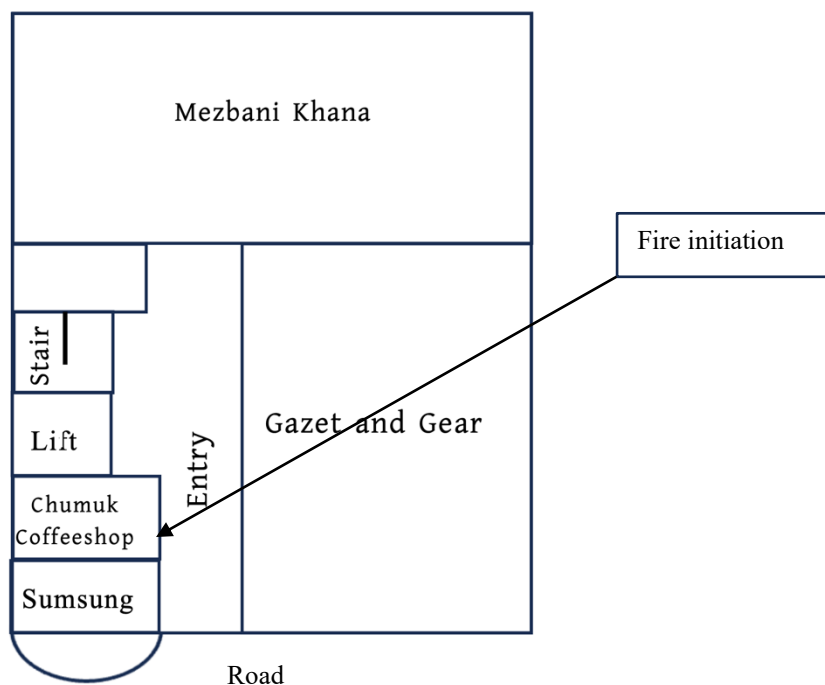
Figure 02: Ground floor layout of Green Cozy Cotez Restaurant

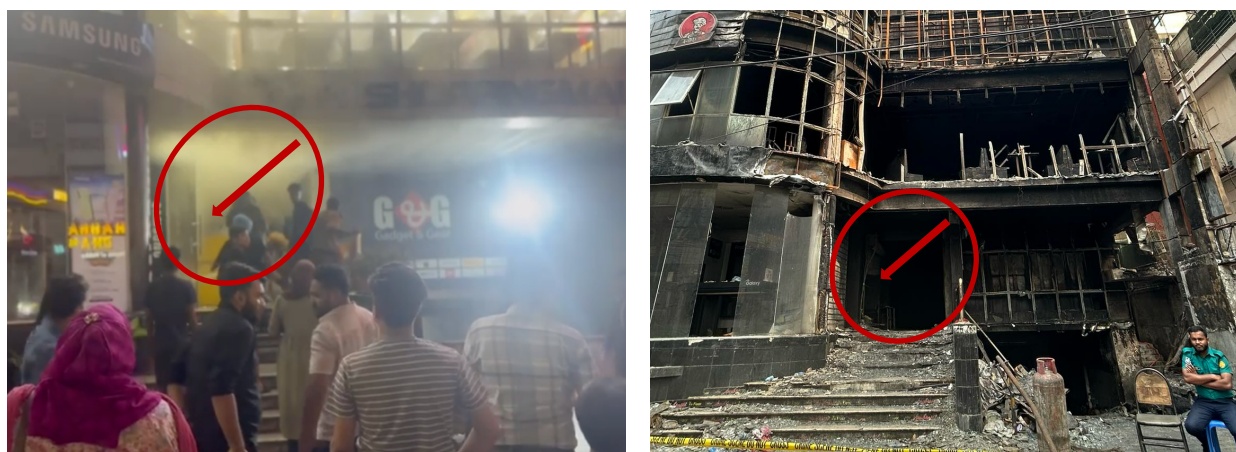
Figure 03: Location of fire source, initial smoke, and fire scene

According to early stage video analysis and eyewitness and fire service personnel interviews, the fire started on the ground floor of the Chumuk Coffee Shop, close to the main door. The precise reasons behind the fire's start remain a mystery. A number of factors, including electrical short circuits, electric heaters, gas leaks, and electrical equipment, can contribute to the start of a fire. LPG gas cylinder was used for cooking at Chumuk Coffee Shop.

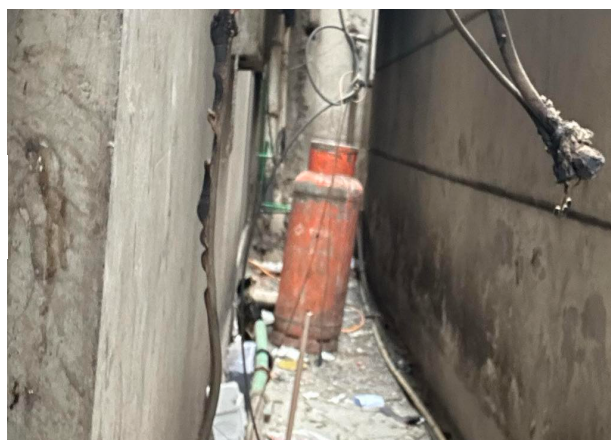
Figure 04: LPG Gas cylinder used in Chumuk Coffeeshop

There was no cylinder inside the coffee shop. As seen in Figure 04, an LPG cylinder was discovered behind the coffee shop and linked with a hosepipe through the wall. This type connection is inherently hazardous. This line will get damaged and leaky in the event of a fire, which will make the fire worse. As a result, if there is a constant flow of gas because of a leak or pipeline failure, the fire will spread very quickly.

- d) Official and employees must have training on basic fire safety and response plan in case of any fire emergency.
- e) LPG gas cylinder should be handled carefully and stored in open and ventilated area. It should not store in a closed space, in emergency exits or staircase and, in an area, where fire risk is high. Substandard connection and pipelines should not be used for gas line installations to avoid risk of gas leakage and potential accident. Metal standard pipeline should be used instead of flexible plastic pipe for gas line connections.

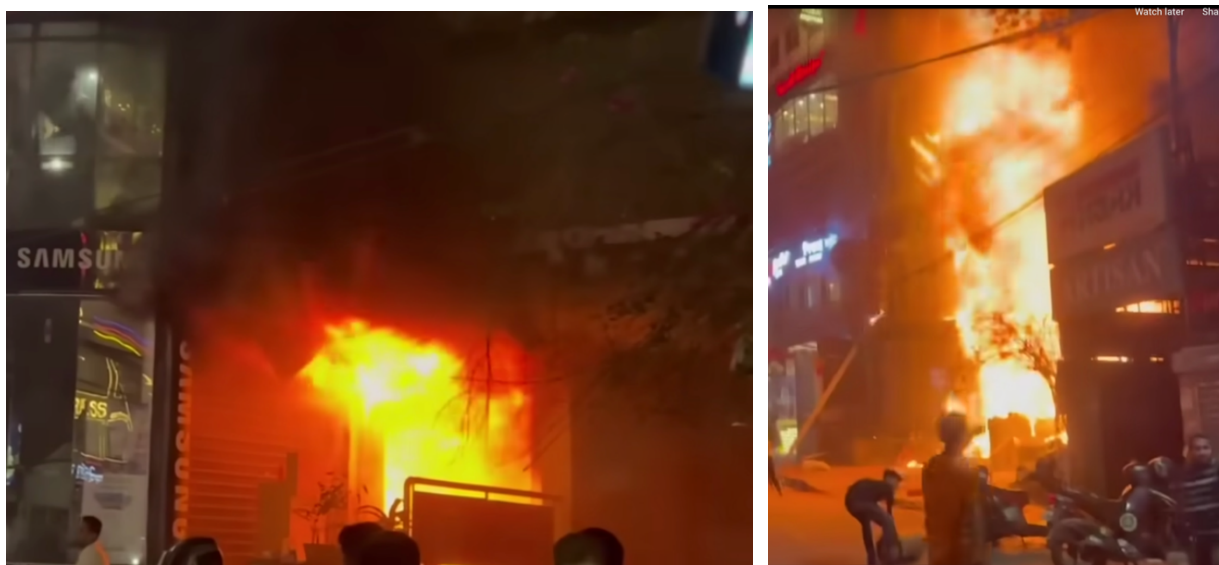
Analysis of the video footage shows that smoke was first observed spreading at the ground floor's main entrance. Afterwards, because of the open area and oxygen availability at the front side of the building, the fire and smoke spread quickly there. The direction of the combustion flame is determined by the availability of oxygen. Even the fire didn't spread in Mezban Khana which is located at ground floor and backside of the building (see Figure 01). In addition to the main entrance, the staircase near the Chumuk Coffee Shop is another point of entry for fire in the building's interior. Smoke and fire swiftly filled the staircase and used it as a chimney to spread. As a result, those who had stayed on the upper level were trapped and were unable to escape using the only stairway that was available. Before the fire fighter arrived at the scene, the fire had reached the flashover stage. Fire spread from ground floor to top floor within 2 minutes as shown in Figure 05 (Left- fire scene at the ground floor before the fire fighter came, Right-fire scene just after two minutes).

Figure 05: Fire spread within two minutes from ground floor to top floor.

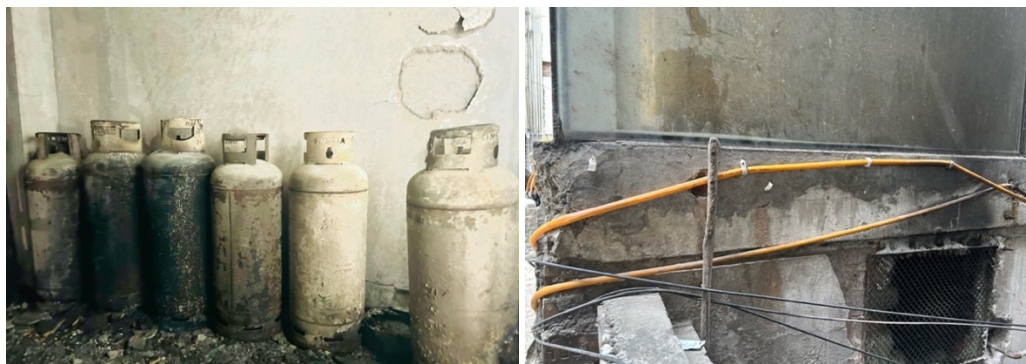
flammable may create such kinds of catastrophic fire scenario. The presence of an LPG cylinder connection, a highly flammable material, a continuous flow of LPG gas into the fire might have devastating consequences due to the high burning rate and significant energy released when burning. Therefore, this tragic fire may be consequence of continuous release of LPG gas due to pipeline failure or presence of gas cylinders in proximity of fire areas. LPG gas cylinder was stored haphazardly inside the building even at the only available staircase as shown in Figure 06.

Figure 06: LPG cylinders stored at the staircase (Left) and gas line connection using flexible plastic pipeline (Right)

The staircase became filled with smoke and fire. In the staircase, there were over 10 42 kg LPG cylinders. The pressure increased because of the heating of these cylinders. When an LPG cylinder encounters heat and flames and its temperature increases to 70 °C, its pressure also increases to 25 atm. Because of the extreme pressure, the cylinder's relief valve activates for preventing an explosion and releases gasses that fuels the flames. Additionally, cylinders were kept outside the building and connected using flexible plastic tubes (see Figure 06). These pipelines can damage in contact with the flames, can continue to supply fuel which would feed and exacerbate the fire.

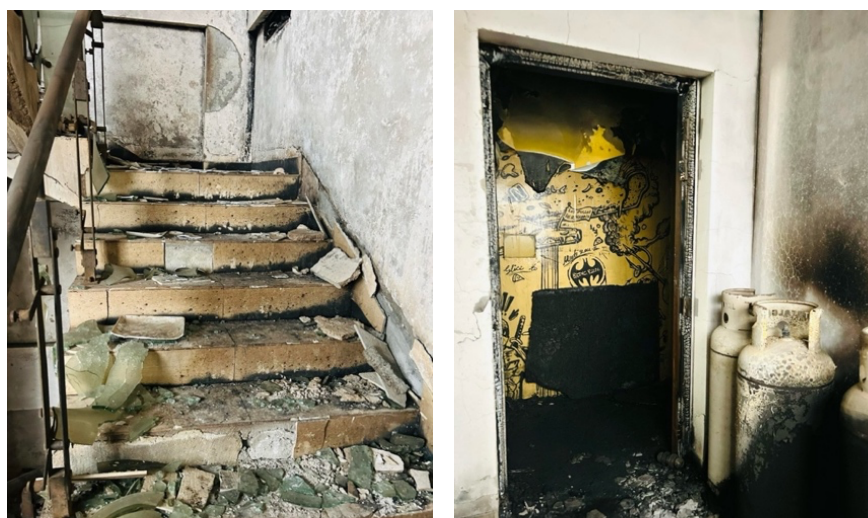
Figure 07: Damaged staircase due to excessive heat (L) and damage doors due to fire (R)

The intense heat produced by the fire, which was caused by cylinders kept inside the stairs, severely destroyed the staircase. As seen in Figure 07, the fire also readily burned through the doors on each story, creating a space where smoke and flames could spread. Due to the irregular fuel load on some floors, the fire didn't go very far, but smoke filled the building's enclosure and nearly every floor.

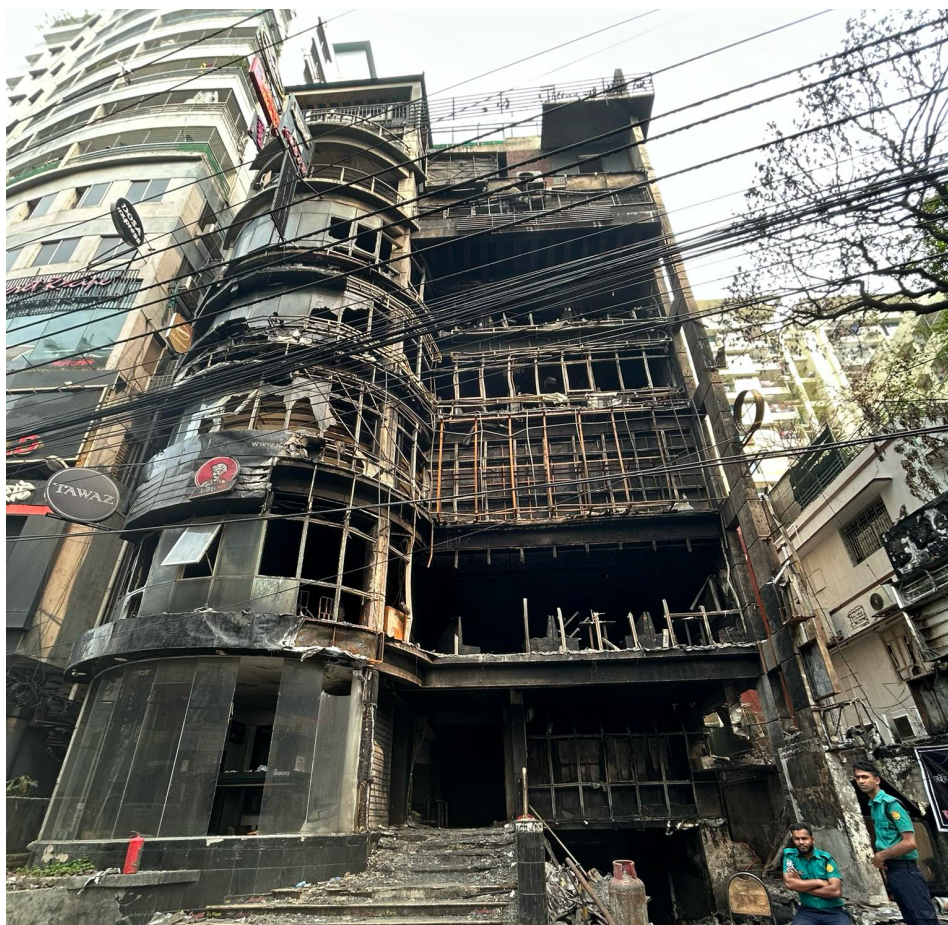
The building featured a narrow entrance, with small and large businesses on either side. The Chumuk coffee shop was located at the entryway, narrowing it further despite not having regulatory agency approval. Interior designers severely disrupted or harmed passive fire safety issues (i.e. fire separations, horizontal and vertical fire separation, introduction of combustible/plastic materials, compartmentalization) as a result of the restaurants' floor-by-floor beautifying. The interior designer installed a thin glass wall to take over the extended and communal areas, demolishing the inside wall in the process. The primary method of fire spread between floors was the breaking of external glass barriers. The building's first and fourth floors, where the vertical fire separation is less than two feet, had extensive fire damage as shown in

Figure 08. This is also supported by the fact that fire didn't spread at the 2<sup>nd</sup> floor as there exist vertical fire separation by solid walls. Therefore, with correct design, the consequences could have been reduced if the fire and smoke had been contained at the ground floor.

Figure 08: Damaged building and exterior glass wall

- c) Fire separation and compartmentalization must not be destroyed during interior design and external beautification. Fire hazard, fire risk and safe passage during emergency has to be addressed in stage of building modifications.

- For any internal and external beautification of the building, fire safety issues must be addressed carefully so that means of egress, horizontal and vertical separation has not been affected.
